COMPLIANCE IS OUR FOCUS

WHO WE ARE

KITCHEN EXTRACTION CLEANING

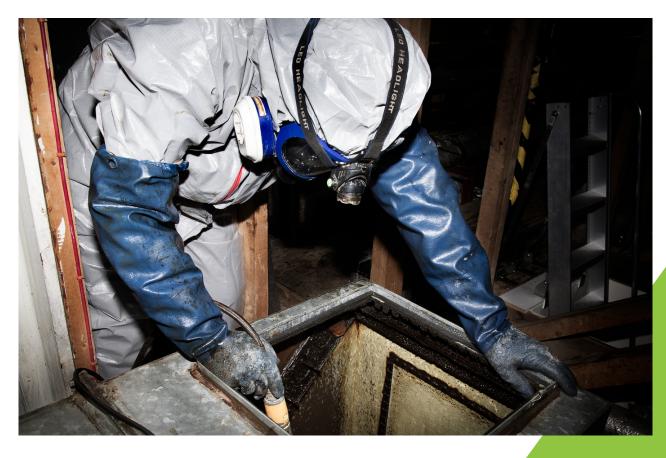
VERTICAL RISER CLEANING

We ensure that the part of the extraction system that vertically exits the building internally and externally is cleaned using our chemical wash method and ensures that the entire system from internal to exit is clean, safe, and meets the national specification required by BESA TR19 Grease recommendations.

Full photographic report and certification of the clean is provided for issue to your insurance company

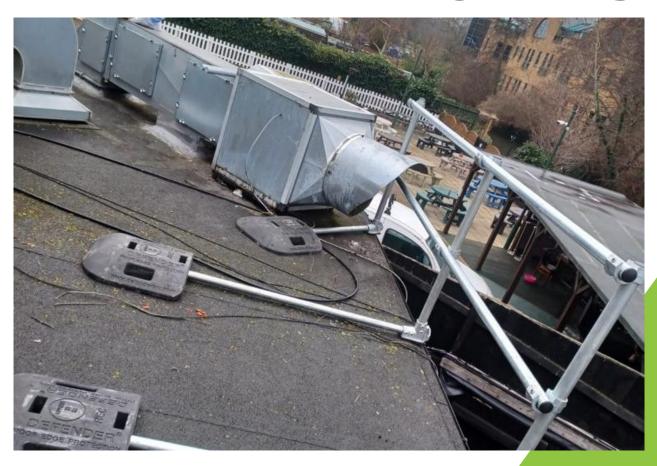
TR19 ACCESS & REMEDIAL WORKS

BESA TR19 Grease regulations require all ductwork to be safely accessible. Our nationwide experienced teams can install access doors, walkways, hatches and any other remedial works to ensure that your system remains compliant in line with the regulations. Ensuring your ductwork is accessible increases the safety of your system and reduces the risk.

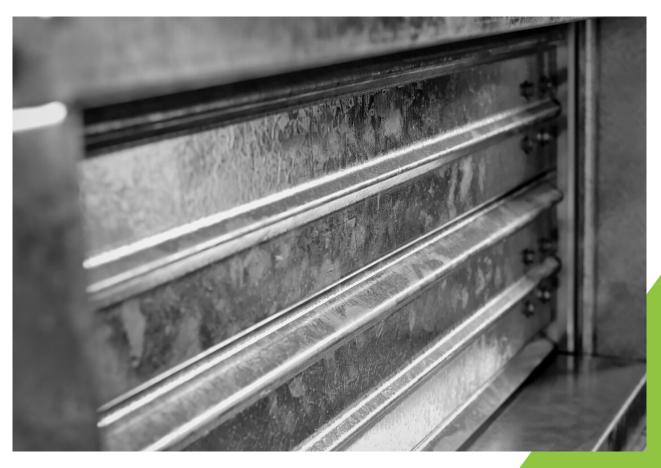
FIRE DAMPER COMPLIANCE

Ensures that in the event of a fire, the spread of flames within the building's ductwork is prevented. Under the Regulatory Reform (Fire Safety) Order it is a legal requirement to test fire dampers at regular intervals in accordance with fire safety in the design, management and use of building code of practise (BS:9999 2017).

Our qualified and experienced engineers will ensure that these fire safety regulations are met, and a full photographic and certified report is provided
