COMPLIANCE IS OUR FOCUS

WHITBREAD CASE STUDY

CASE STUDY

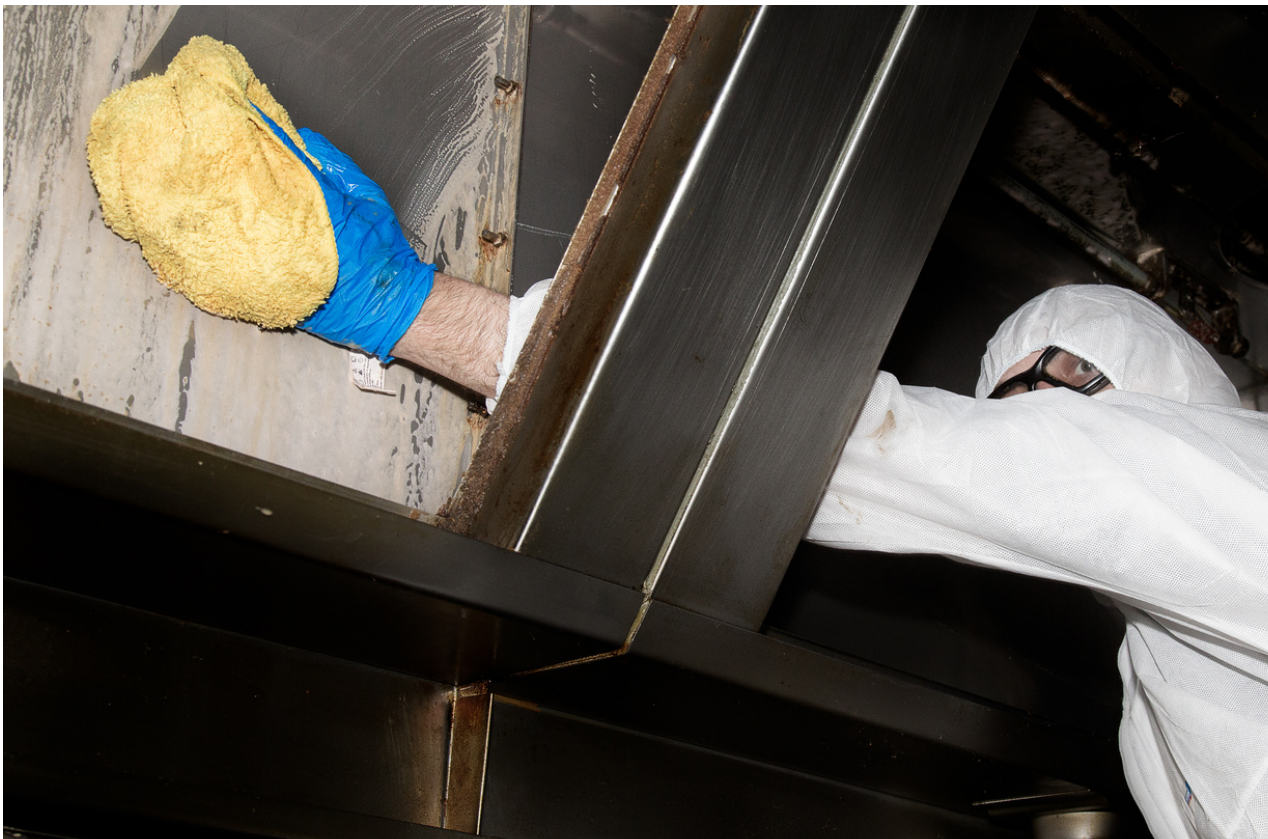
KITCHEN EXTRACTION CLEANING

Ensures a healthy and safe environment for all employees and customers. Regular cleaning and removal of grease, oil and any other deposits that accumulate in the system ensure that the site is compliant, and the risk of FIRE is substantially reduced.

Our nationwide teams adhere to the regulations and guidance of BESA TR19 Grease by cleaning the entire system using safe methods and provide a full photographic report and certification of the clean for issue to your insurance company

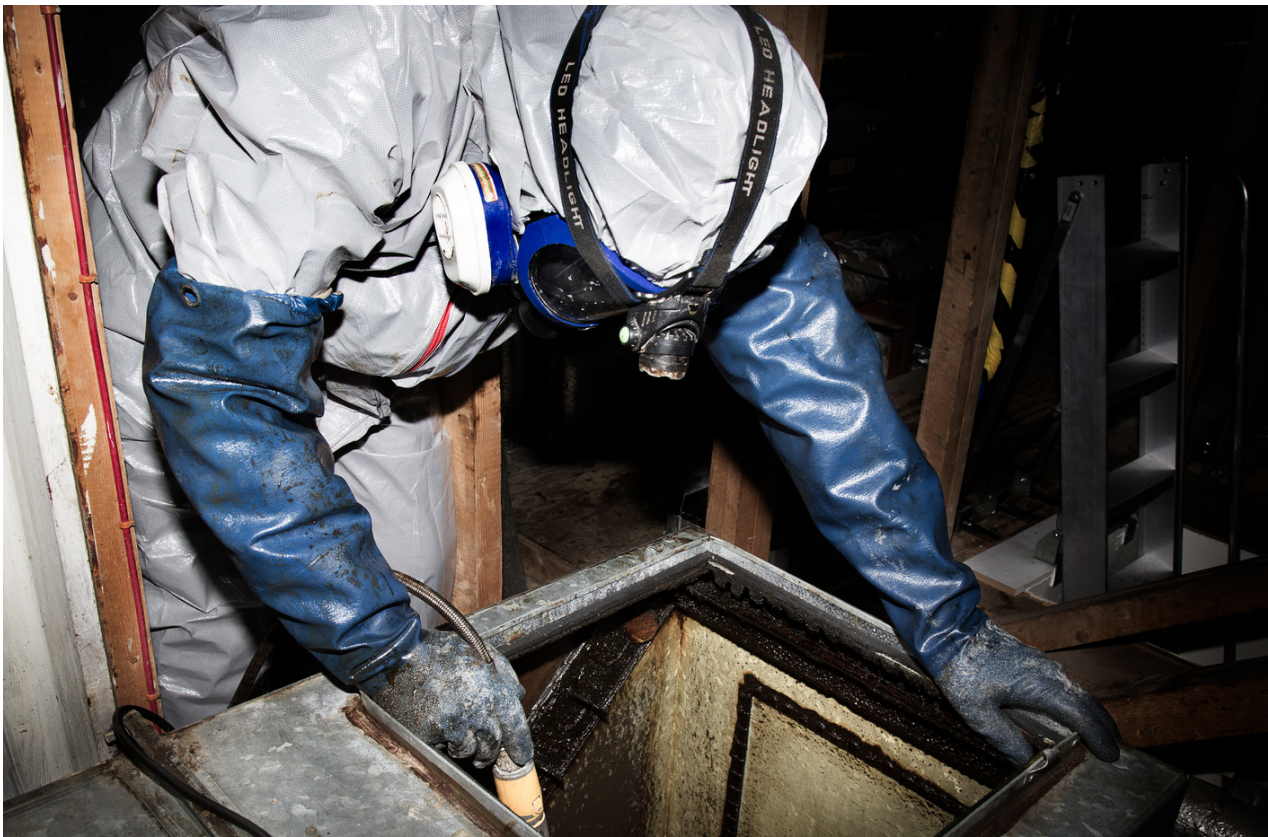
VERTICAL RISER CLEANING

We ensure that the part of the extraction system that vertically exits the building internally and externally is cleaned using our chemical wash method and ensures that the entire system from internal to exit is clean, safe, and meets the national specification required by BESA TR19 Grease recommendations.

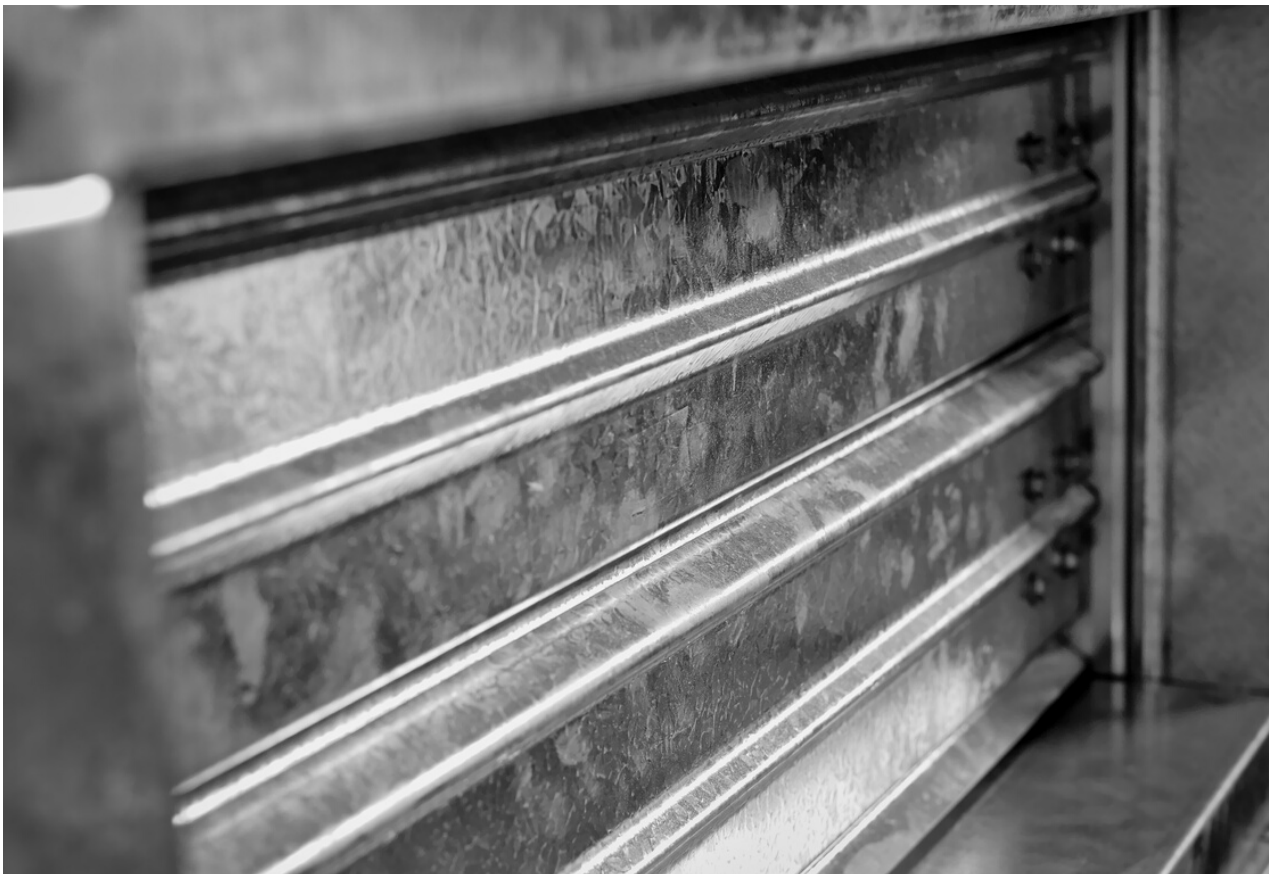
FIRE DAMPER COMPLIANCE

Ensures that in the event of a fire, the spread of flames within the building's ductwork is prevented. Under the Regulatory Reform (Fire Safety) Order it is a legal requirement to test fire dampers at regular intervals in accordance with fire safety in the design, management and use of building code of practise (BS:9999 2017).

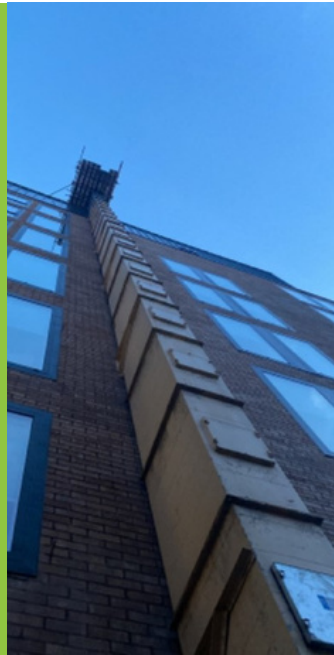
An eleven story riser constructed up the side of a hotel. Access to the riser using vertical scaffolding was not viable. A counter-lever scaffold system was erected on the top of the building giving the team access to the length of the riser system.

This method allowed unhindered safe access for the engineers to commence and complete the clean using our award winning chemical clean process.

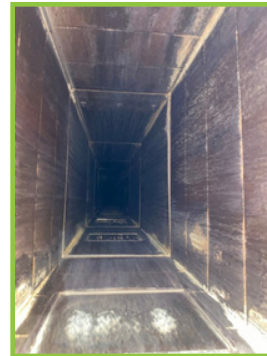
After

Our unique method supports the engineers in cleaning the entirety of the system using our specially formulated chemical and bespoke equipment
